#### **TEST REPORT**

Report No.: B9447.01-301-16

# SUNOPTICS PRISMATIC SKYLIGHTS Sacramento, California

SERIES/MODEL: Safety Security Guard PRODUCT TYPE: Skylight Fall Protection System

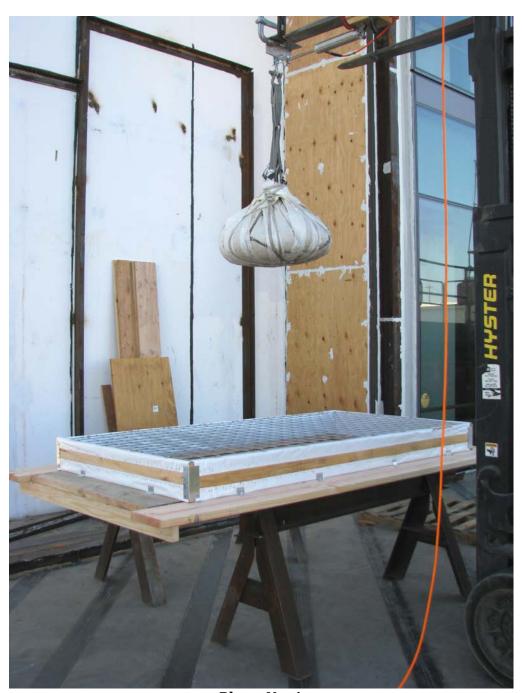
Photo No. 1 Drop test setup, test weight at 42" above screen

**4.1 Test Weight**: 400 lb. bag of sand approximately 30" in diameter

**4.2 Drop Height**: 42" above the screen

The specimen was installed into a test curb fabricated from nominal  $2 \times 8$  Douglas fir lumber. To simulate attachment to a roof, the curb was fastened to four  $2 \times 10$  boards laid flat. The Skylight Screen was fastened to the top edge of the curb. The assembly was supported 40" above the ground on heavy duty steel stands.

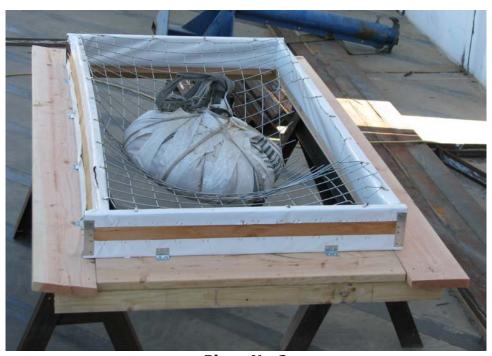
Photo No. 2 After impact, screen is holding test weight

**Note 2**: The test weight was left in place for a period of 5 minutes after impact. The screen held the weight without showing signs of further weakening. While still holding the weight after impact, the total deflection of the center of the screen was 18" below the top of the curb.

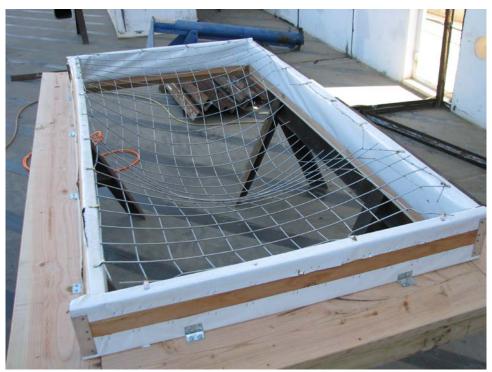
Photo No. 3 After removal of test weight

**Note 1**: The test weight did not fall through. Visual damage was observed, including screen welds broken, anchors pulled out, and two corner joints of the test curb partially detached.
